Disaster Governance in India

SERIES - 5

CENTRE FOR DISASTER MANAGEMENT

Lal Bahadur Shastri National Academy of Administration, Mussoorie-248179

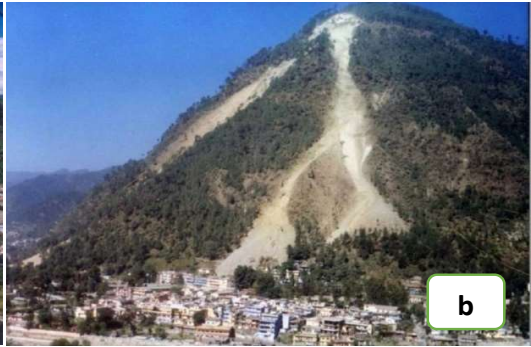
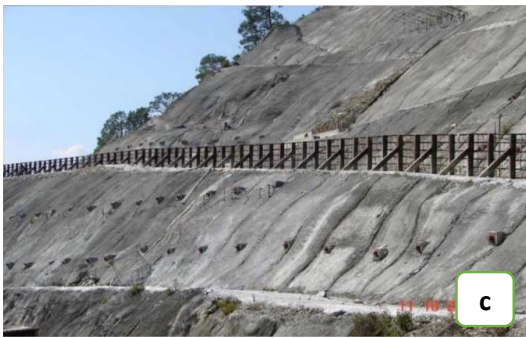
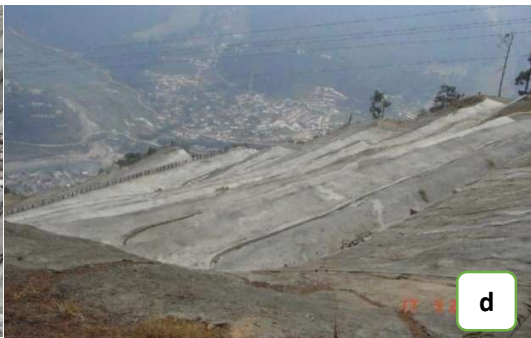
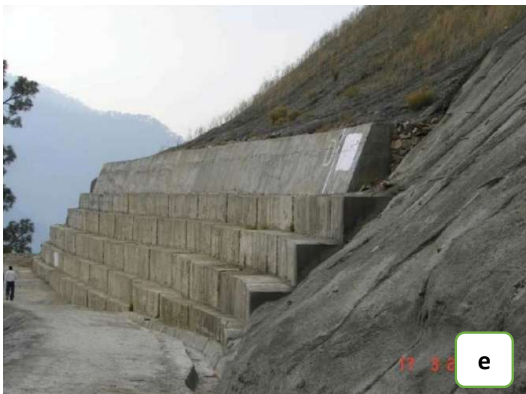
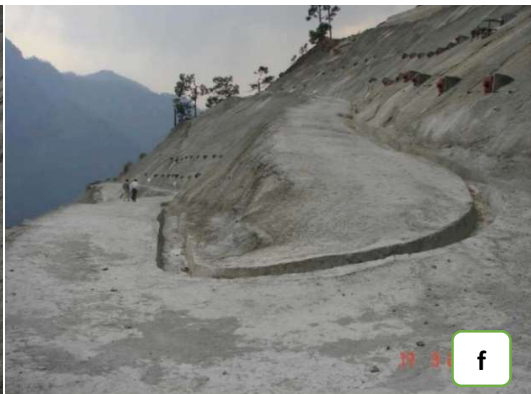
Progress and construction works taken at Varunavrat parvat, Uttarkashi:

- a) Before disaster; b) Post –Disaster (view from left bank); c) Platform and steel Barricading at El 16770; d) Treated benches and slopes; e) Concrete Cladding; f) Drain on Benches; g) Installed cable anchors; h) Geogrid; i) geo-jute; j) vegetation and ecological management; k) Catchpit of geogrid wall

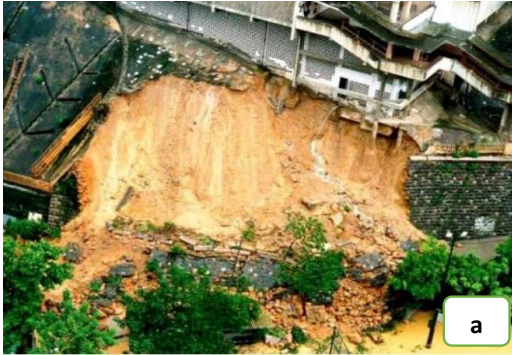
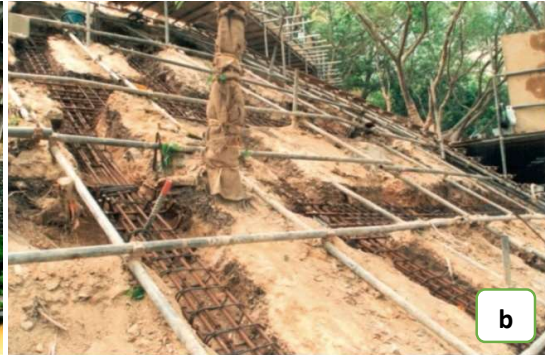
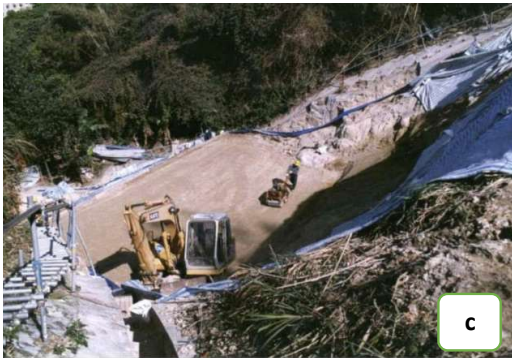
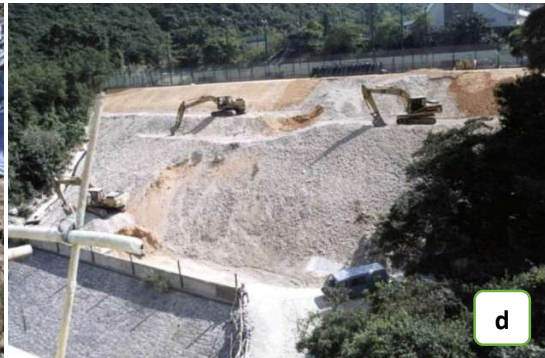
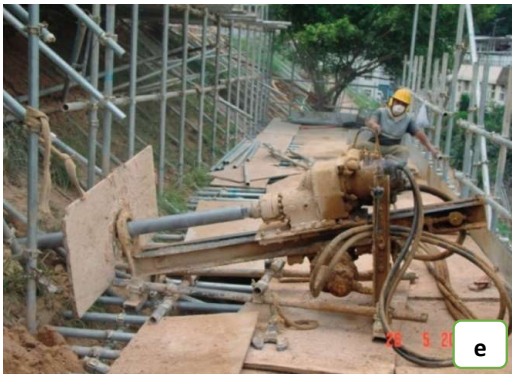
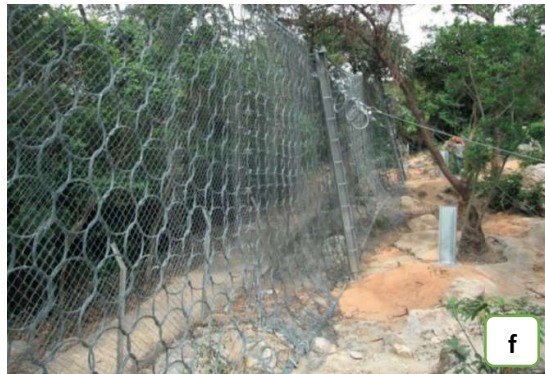
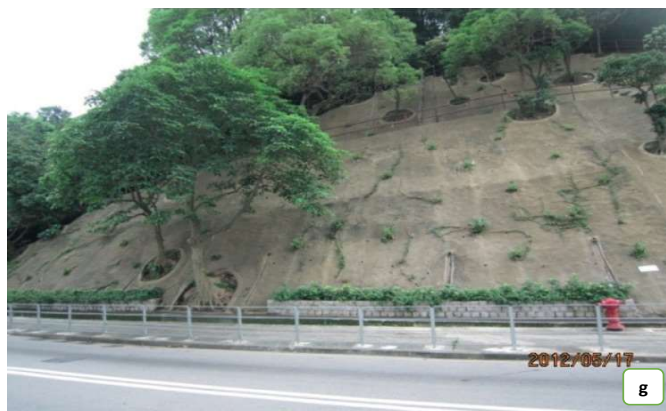
Figures illustrating:

- a) 1994, fatal landslide at Kwun Lung Lau;
- b) Soil nails and grillage;
- c) Recompaction
- d) Application of rock-fill cap;
- e) Construction of nails in soil cut slope;
- f) Flexible barrier at toe;
- g) Plantar holes and toe planter

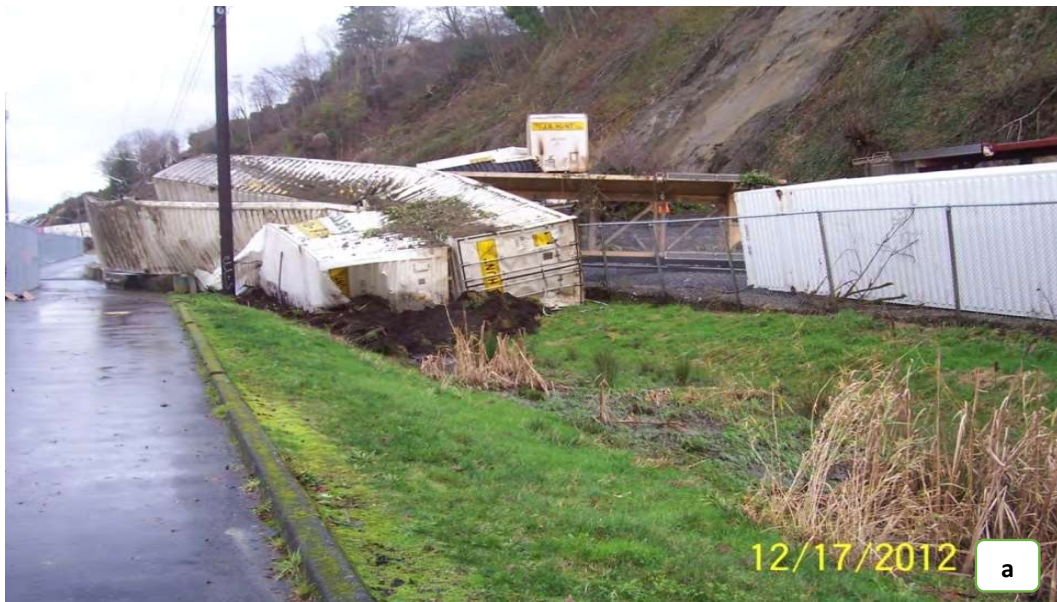
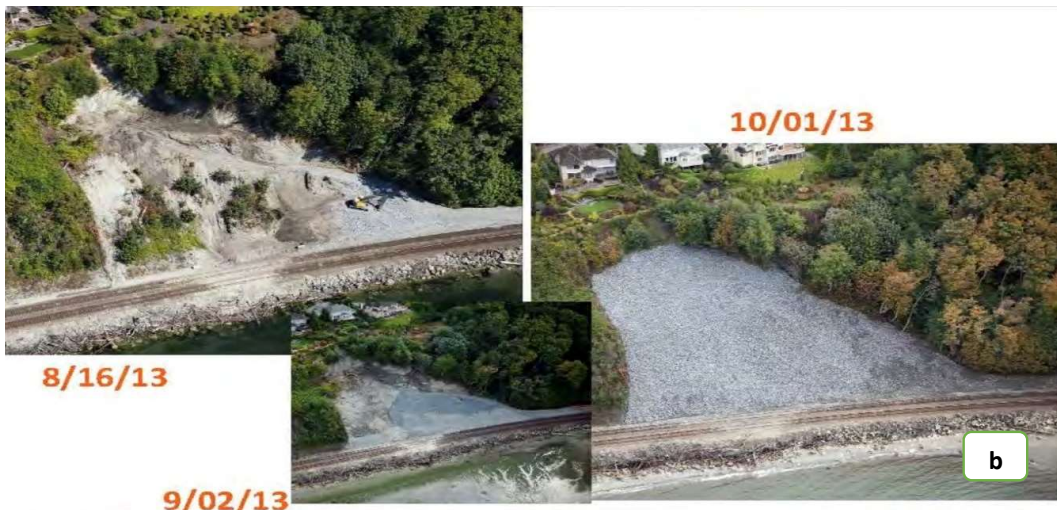
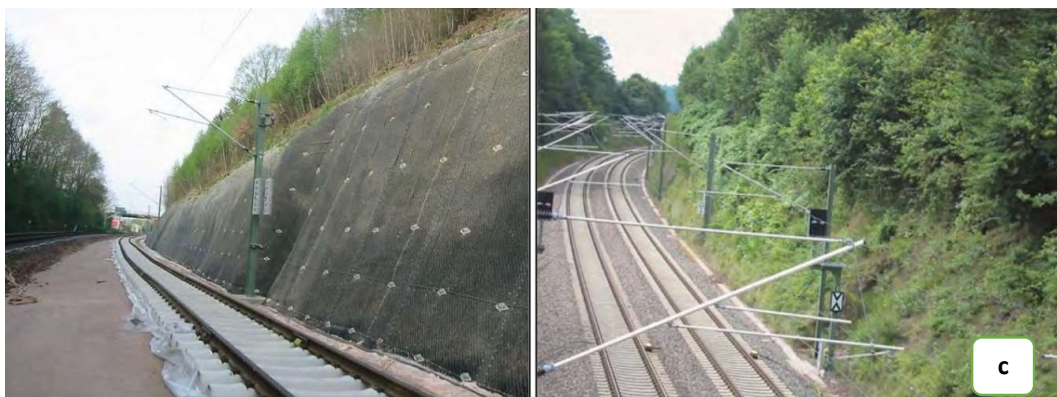
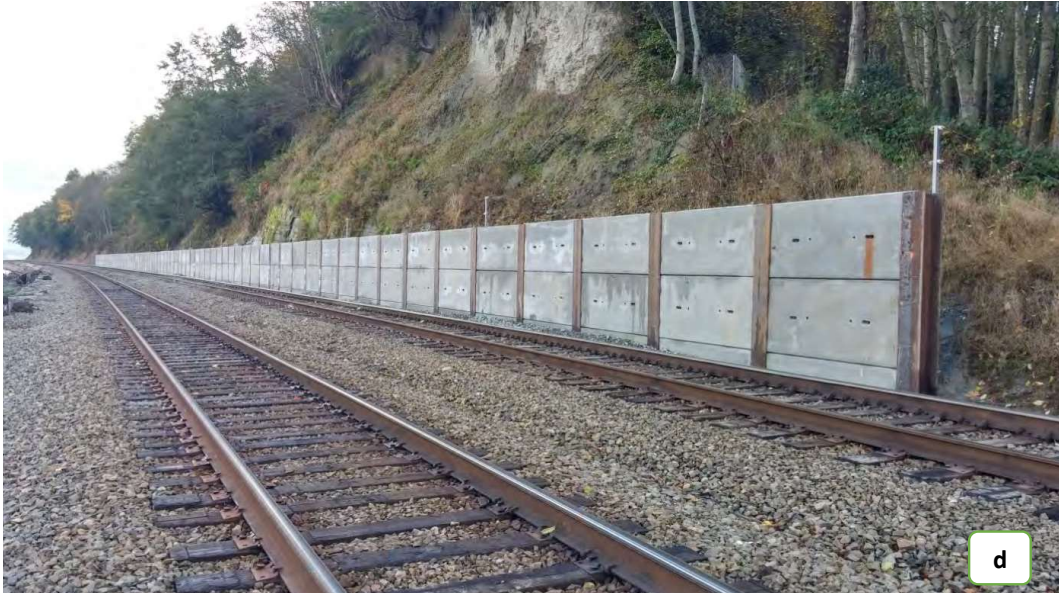
Figures illustrating:

- a) Train Car derailed by landslide b) Slope reinforcement project undertaken
c) Reinforcement using high tensile steel wire mesh d) Debris containment wall

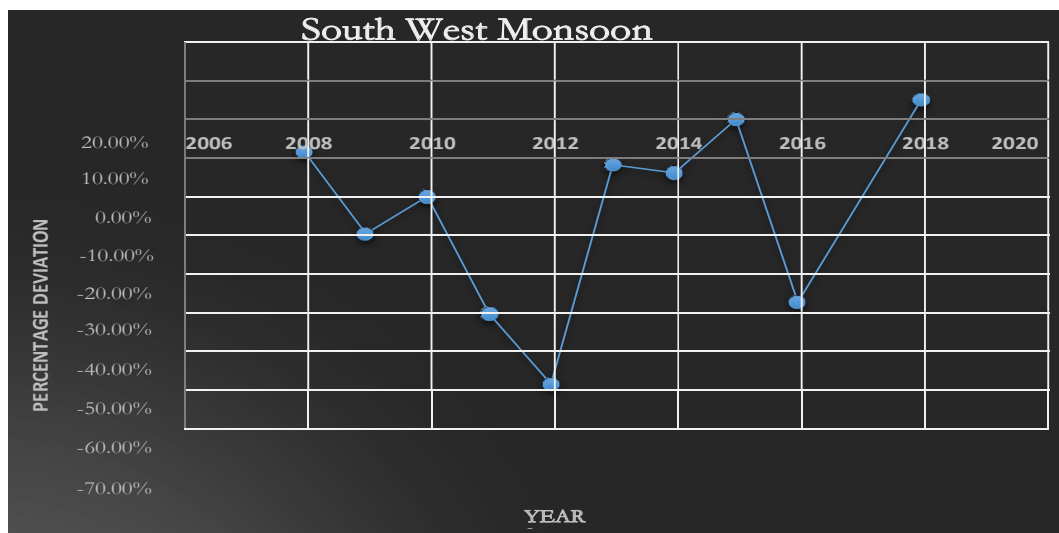
As the figure depicts, in a 10-year period, 2018 saw the highest ever rainfall that was received in the South West Monsoon. It is to be further noted that while in the month of July, Kanyakumari received 150mm rainfall, in only two days, Kanniyakumari received 170 mm rainfall. Further, in the 24-hours till 8 am on Wednesday, Kanyakumari district recorded an average rainfall of 94.45 mm. Thus, the primary cause of the floods was the unprecedented rainfall in the catchment areas of Perunchani and Pechiparai. The South West Monsoon was further aggravated by the presence of a very high Northeast Monsoon in the year 2017, as a result of which the dam level was already high. The rainfall in the last year is depicted in the following table.

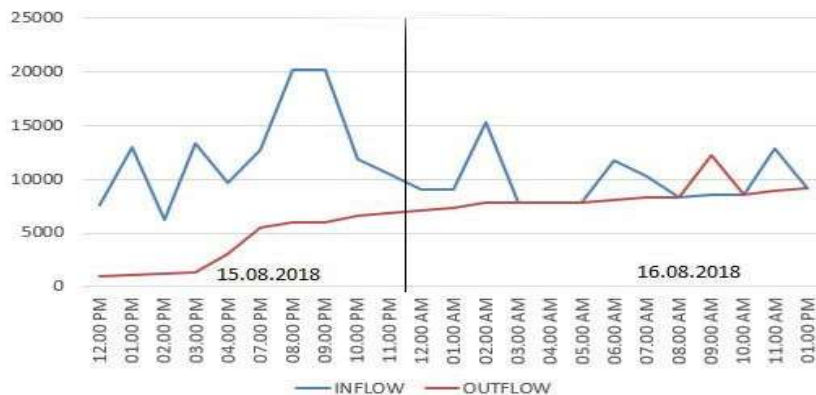
In this dam, the inflow steadily increased to 7000 cusecs at 12 noon on 15.8.2018. However, the outflow was consciously kept at 900 cusecs. Even when the inflow increased to 13000 cusecs, the decision was made to hold the water and to let the dam level increase. The dam level was allowed to reach till 37.40 feet till 12th midnight of 15th and 16th night, when the maximum capacity was 39 feet. It was only at 8 am on 16.8.2018 that the outflow was made to increase the inflow to moderate the level in Pechiparai dam.

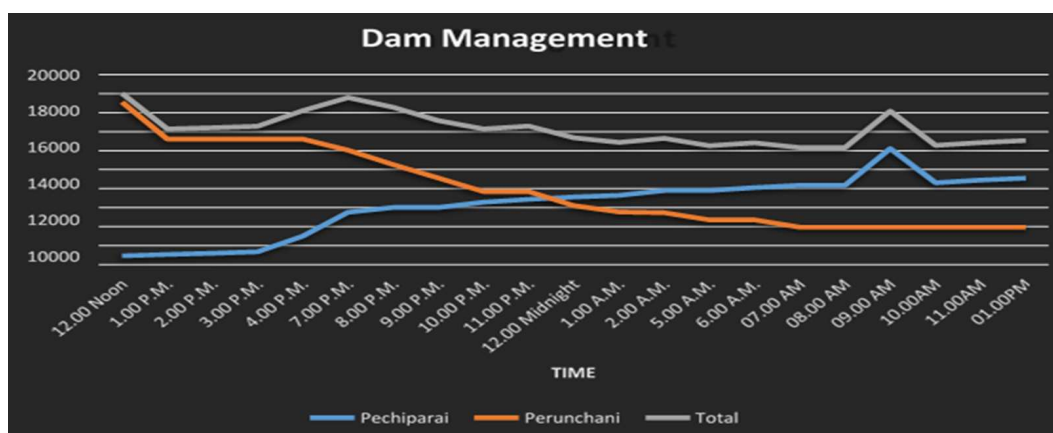
As mentioned above, the management of both the dams allowed that neither of the dams at any instance reached the breach barrier. Simultaneously neither of the dams, together, released more water than 30000 cusecs, as shown in the chart below.

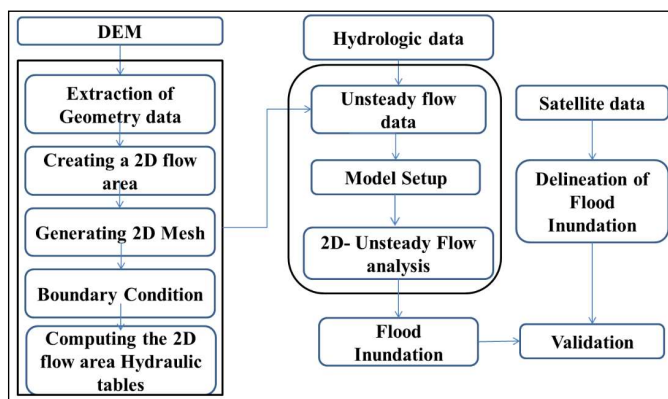
HEC-RAS 5.0.1 version was used to simulate flood inundation due to overflowing of Nalas. HEC-RAS has capabilities to solve 2D Full momentum equation (Saint Venant equation) or 2D Diffusion wave equation. For the present study, full momentum equations were used as it includes all parameters for simulations. The brief outline of the methodology is shown in figure 2.

Figure-2 : Methodology for HEC-RAS

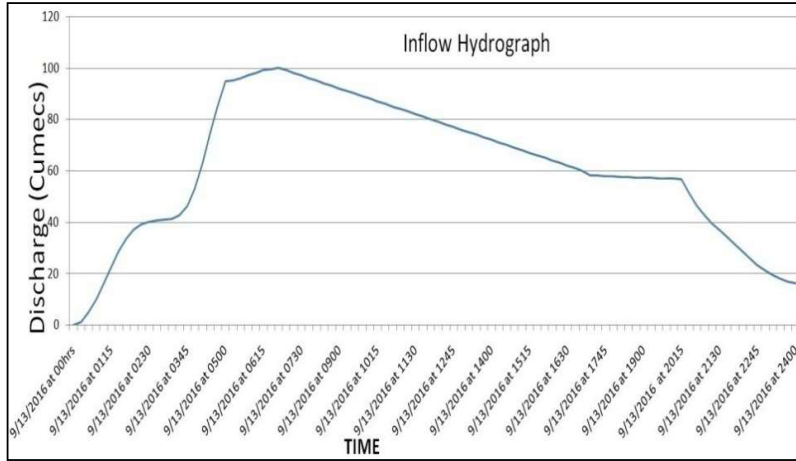
Figure-6 : Inflow hydrograph boundary condition at Qutubullapur

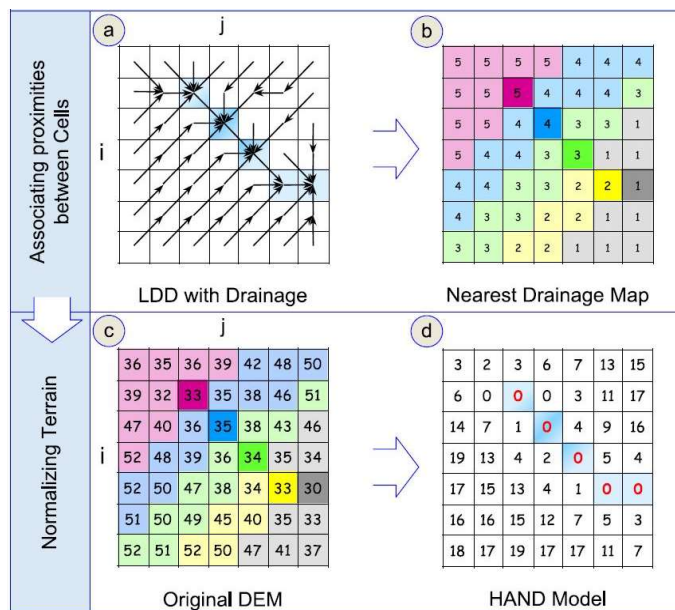
The application of the HAND model provides the possibility of capturing and examining heterogeneities in local environments in a quantitative and widely comparable manner²⁰. The HAND model normalizes the topography in respect to the drainage network through two sets of procedures on a DEM. First, it runs a sequence of computations to create a hydrological coherent DEM, define flow paths and delineate the drainage channels as shown in figure 8. The correct definition of the stream network is the key to the HAND procedure because the elevations of the drainage channel system are used to calculate the normalized terrain heights. Depressions in the DEM data can interfere with the determination of flow directions²⁰.

Figure-8 : Methodology for Hand Model
